Acoustical Evaluation of a Single Family Attached Steel Frame Modular Housing System Constructed on an Operation Breakthrough Prototype Site

Final Report

Thomas L. Quindry
Applied Acoustics and Illumination Section
Building Research Division

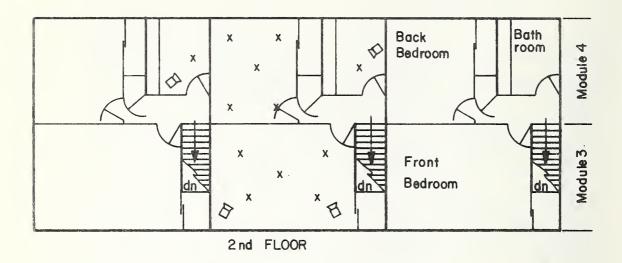
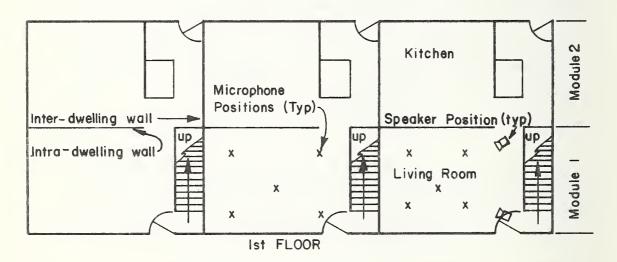
Figure 1. Floor plan of housing system showing microphone and speaker positions.

During the testing several observations were made. For instance, the steel studs in the partition separating the front bedroom and the stairway, as shown in Figure 1, vibrated noticeably when 1/3-octave band pink noise at 125 Hz center frequency was generated in the front bedroom

through the speakers. In addition, by pushing on the plywood paneling on this wall in the bedroom the rattling noise characteristics changed. It appeared that the paneling was loosely fastened to the studs.

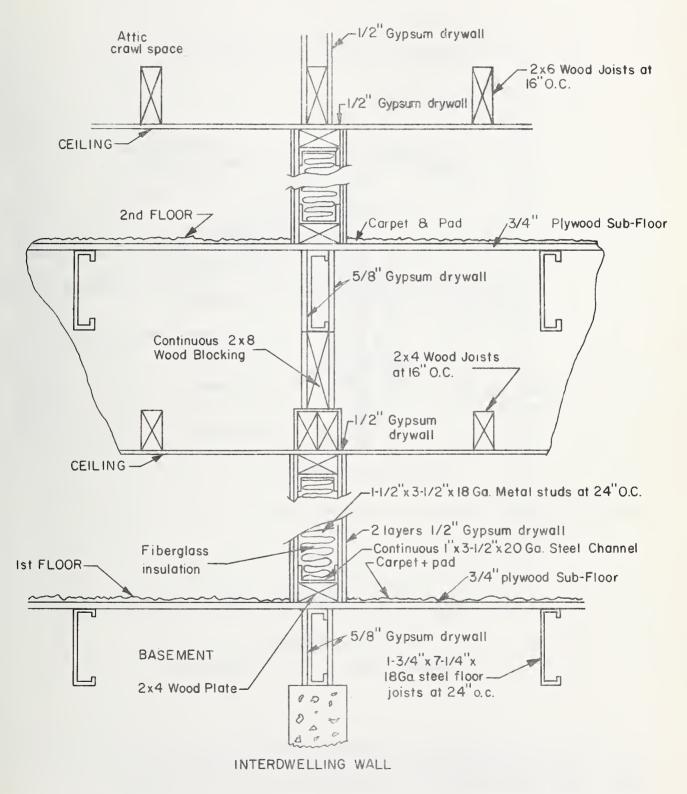
The party wall shown in Figure 2 is constructed of two layers of 1/2-inch gypsum drywall placed on each side of 1-1/2 inch \times 3-1/2 inch \times 18 Ga steel channel shaped studs spaced 24 inches on center. The studs are supported continuously top and bottom by 2 \times 4 (nominal) wood plates and 1 inch \times 3-1/2 inch \times 20 Ga steel channel. Four-inch thick friction fit fiberglass insulation is placed between the studs. The wall is supported on a continuous 3/4-inch plywood floor which is common to both units.

The floor assembly for both the first and second floor as shown in Figure 2 consists of 1-3/4 inch x 7-1/4 inch x 18 Ga steel channel shaped joists spaced 24 inches on centers to which is attached 3/4-inch plywood subfloor. The ceiling assembly consists of 2 x 4 (nominal) inch wood joists spaced 16 inches on center with 1/2-inch gypsum drywall as the finish ceiling. The floor/ceiling space between the second floor and first floor party walls consists of: two 2 x 4 (nominal) inch wood joists, 2 x 8 (nominal) inch wood joist, 1-3/4 inch x 7-1/4 inch x 18 Ga steel channel, and 5/8-inch gypsum drywall.

Figure 2. Section through inter-dwelling wall and intra-dwelling floor-ceiling assemblies.

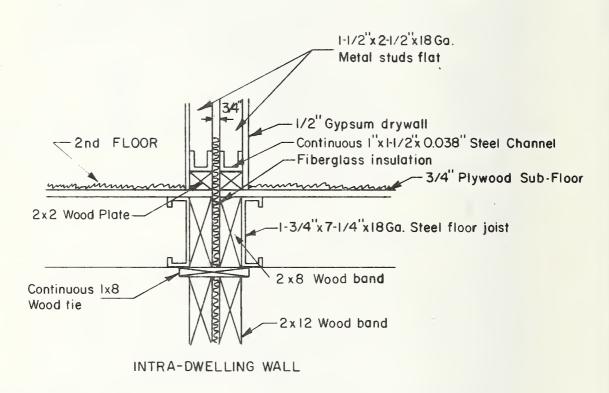
The walls between modules within a given dwelling unit consist of double 1-1/2 inch x 2-1/2 inch x 18 Ga steel channel shaped studs placed with the webs parallel to the wall at 24 inches on centers with 1/2-inch gypsum drywall on the outer surfaces as shown in Figure 3. The floor is not continuous under these walls.

Figure 3. Section through intra-dwelling wall.

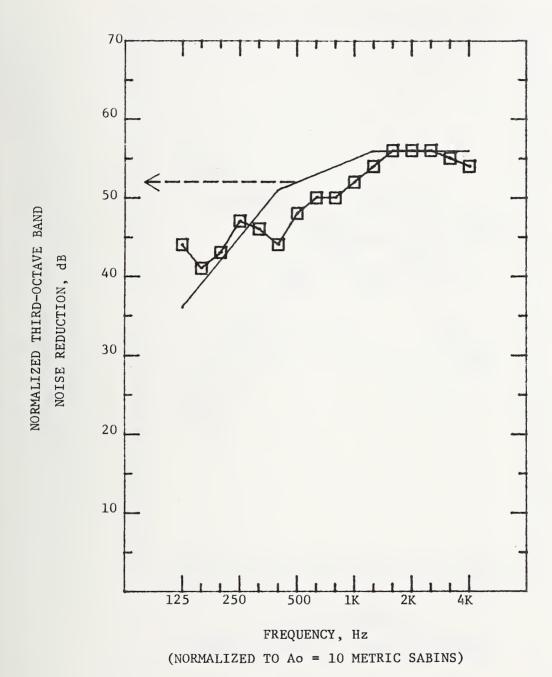
Figure 4. Normalized 1/3-Octave Band Noise Reduction Between Two Living Rooms Separated by an Inter-Dwelling Wall. Units 13-SFA/03-15 and 13-SFA/03-14 (includes stairway buffer zone) (NIC - 52).

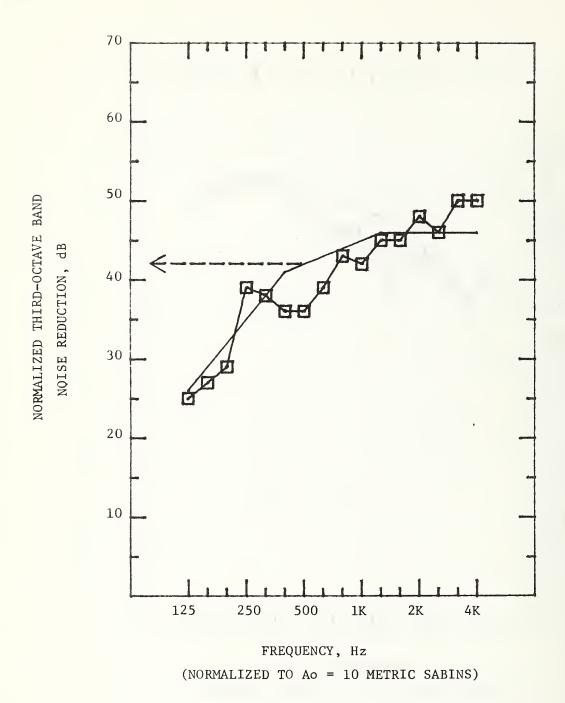
Subjective observations were made to try and determine the cause of the lesser acoustical performance of the party wall separating the bathroom and back bedroom of two units. The generated sound seemed to have less attenuation through the party wall in the area of the shower stall. According to available plans and specifications two layers of gypsum drywall are supposed to cover the entire party wall in the bathroom including the area behind the shower stall. The NIC value obtained from the measured data along with the subjective observations indicate that a major sound flanking path occurs in the shower stall area. This might indicate that one or both layers of gypsum drywall had not been placed full length in the area behind the shower stall.

Figure 5. Normalized 1/3-Octave Band Noise Reduction Between a Bathroom and a Back Bedroom Separated by an Inter-Dwelling Wall. Units 13-SFA/03-13 and 13-SFA/03-14 (NIC - 42).

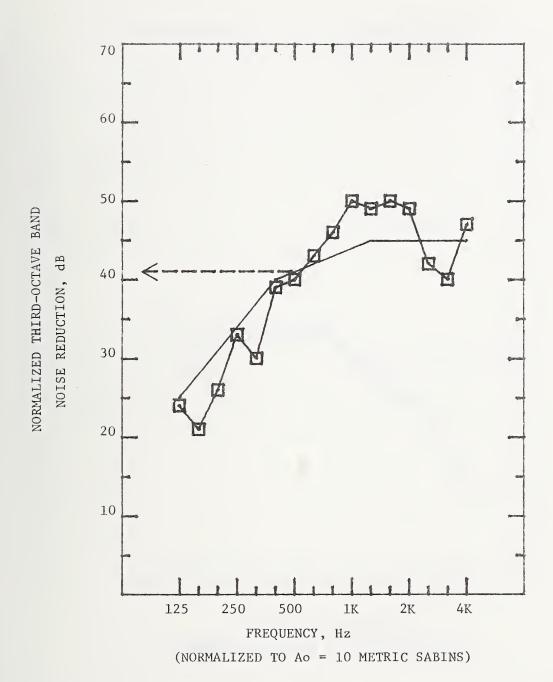
Figure 6. Normalized 1.3-Octave Band Noise Reduction Between the Front Bedroom and a Back Bedroom Separated by an Intra-Dwelling Wall. Unit 13-SFA/03-14 (NIC - 41).

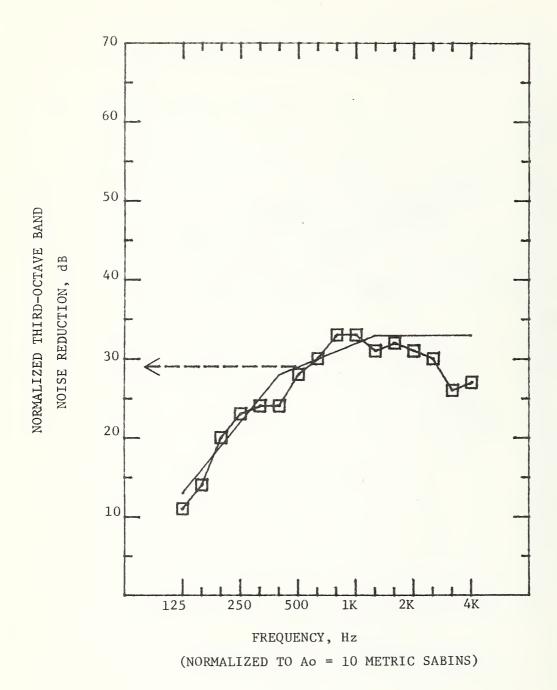
Figure 7. Normalized 1/3-Octave Band Noise Reduction Between a Bathroom and a Back Bedroom Separated by an Intra-Dwelling Wall. Unit 13-SFA/03-14 (NIC - 29).

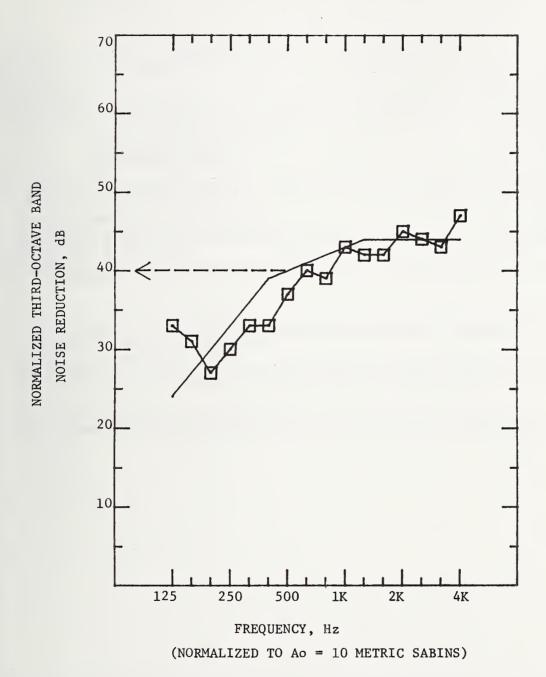
Figure 8. Normalized 1/3-Octave Band Noise Reduction Between a Front Bedroom and a Living Room Separated by an Intra-Dwelling Floor-Ceiling Assembly. Unit 13-SFA/03-14 (NIC - 40).
